Quick Solder Installation Manual

Xenium Quick Solder Installation Manual

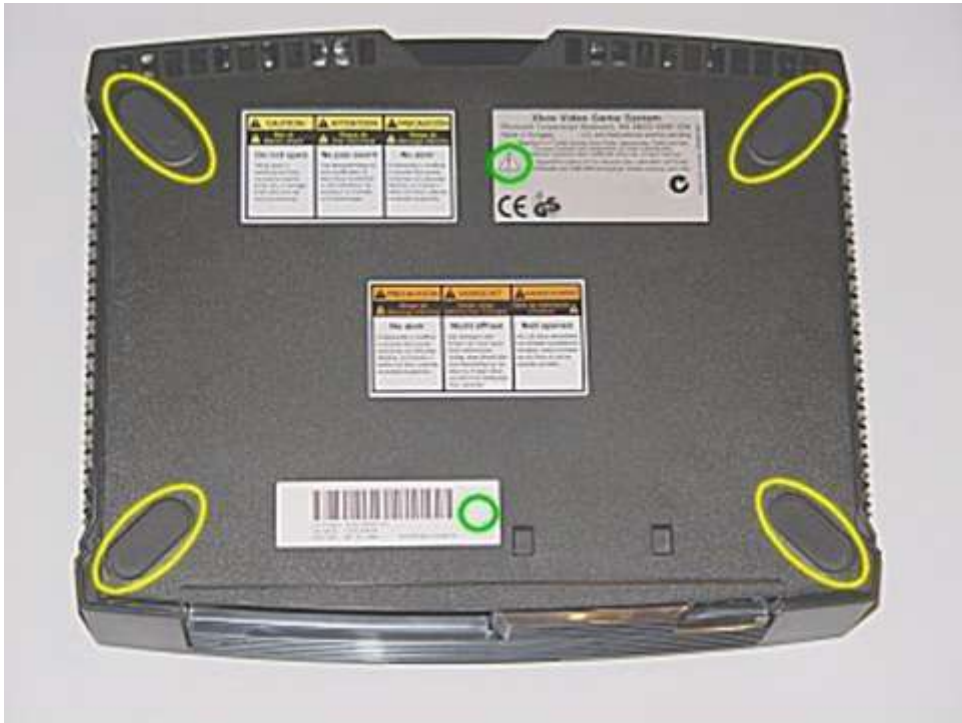
To disassemble your XBox console you must first remove the cover, you will need a Torx 20 screwdriver to do this and the image below indicates the location of six torx screws that must be removed.

You will need to lift the consoles feet up as displayed in the picture below to access four of the torx screws. The green circles above indicate the location of two torx screws that are hidden under stickers, remember that breaking these stickers will void your warranty but it is the only way that you can install the Xenium.

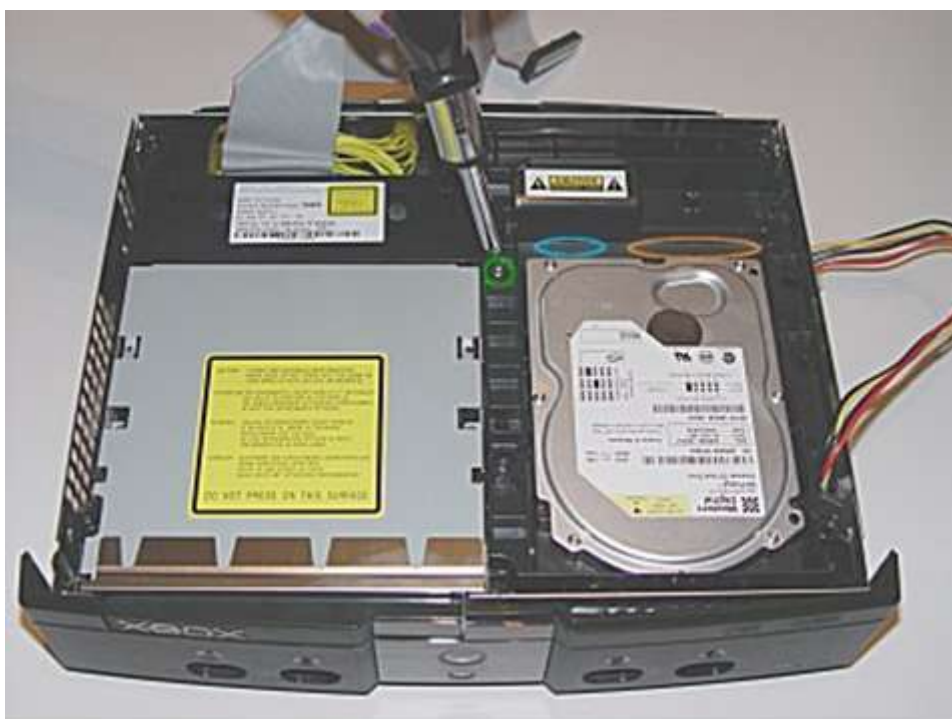
Now remove the IDE cable (marked in orange) and the power cable (blue) from the hard disk drive. A torx 10 screw as indicated in green needs to be removed to allow the hard disk to be removed from the console.

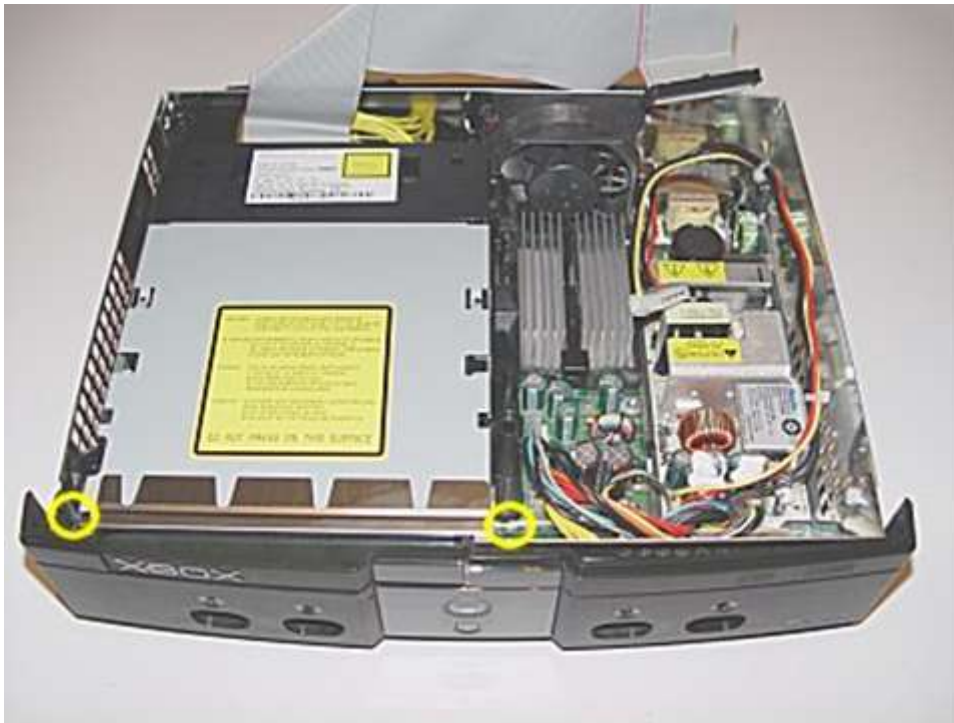
With the hard disk removed you must now remove two torx 10 screws as indicated by the yellow circles.

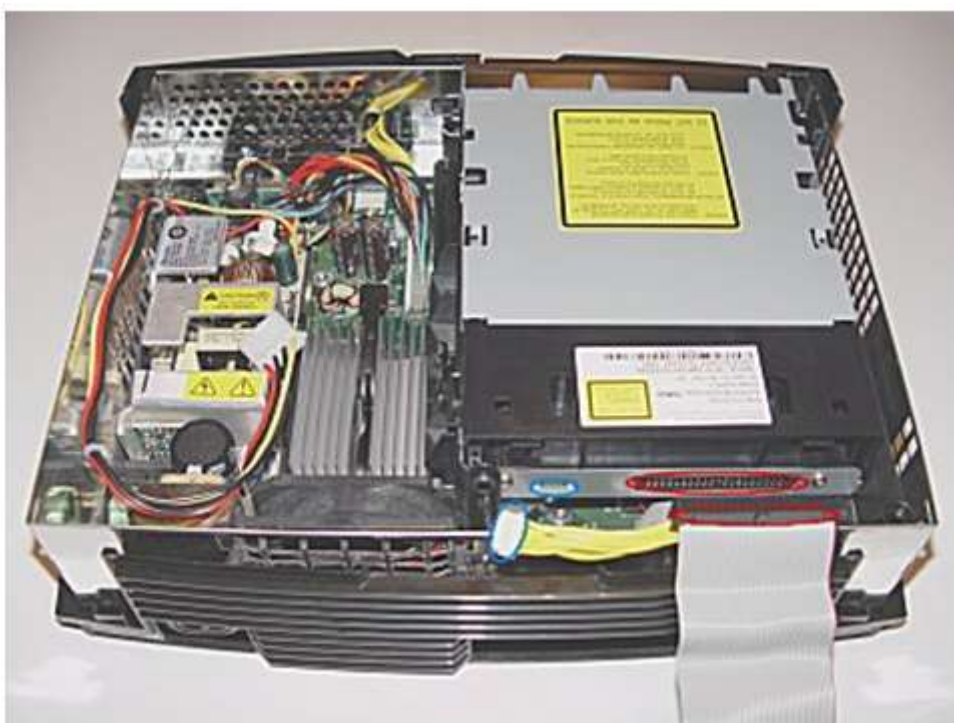
Remove the IDE and power cables from the DVD-Rom drive as indicated by the red and blue circles. You can then remove the DVD-Rom unit and the IDE & Power cables.

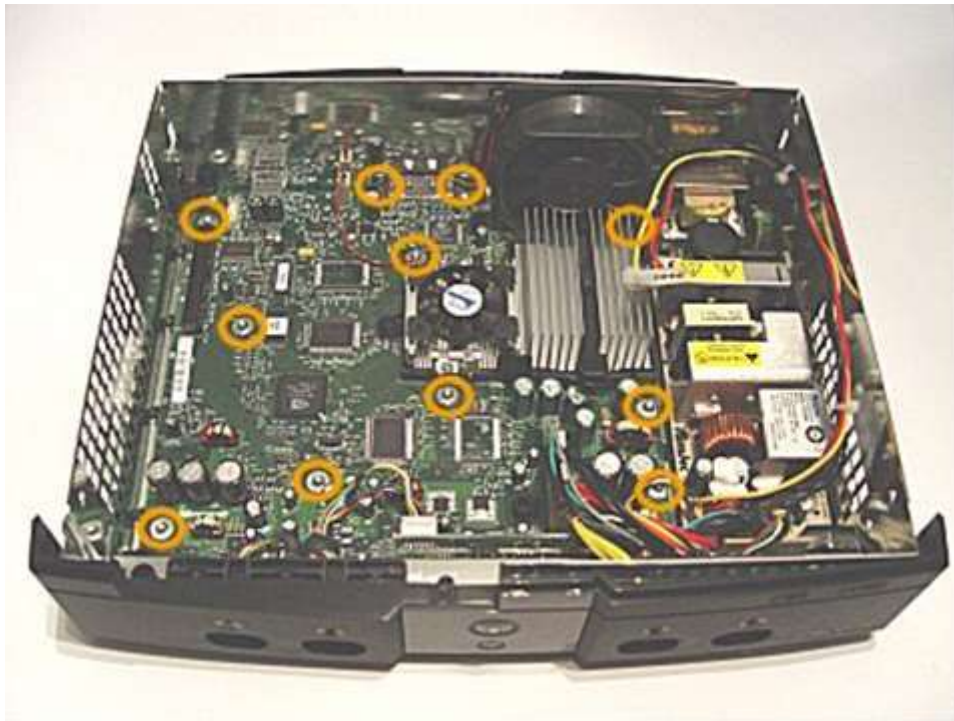
You can now clearly see the Xbox's motherboard, to remove the motherboard you need to unscrew the eleven torx 10 screws as indicated by the orange circles. The fan on the GPU heatsink indicates a version 1.0 motherboard.

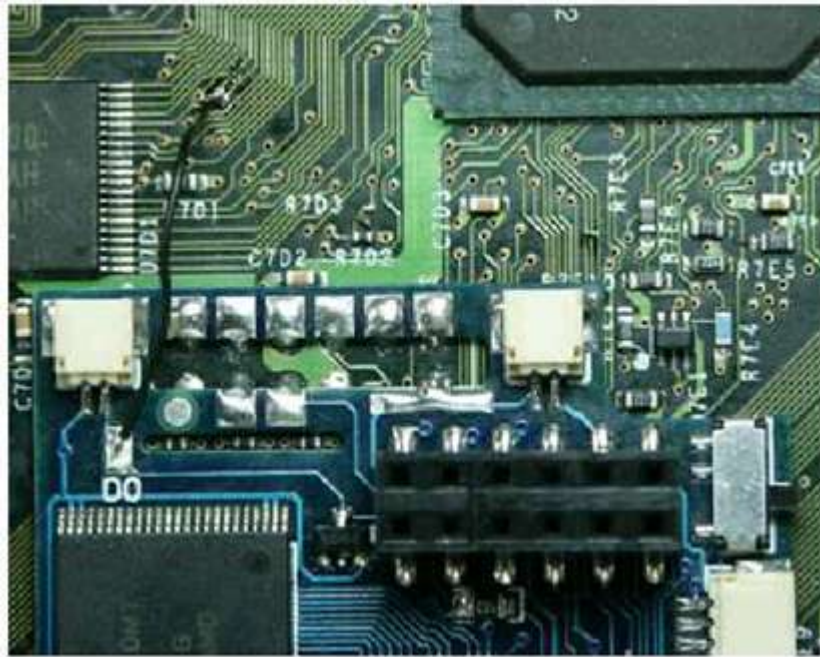
Once you have determined which d0 point you wish to use for your installation you need to solder a piece of single strand wire (Kynar 30AWG) from this d0 point to the d0 solder pad located on the Xenium as shown below.

The photo above shows the Xenium's d0 pad connected to the upper d0 point.

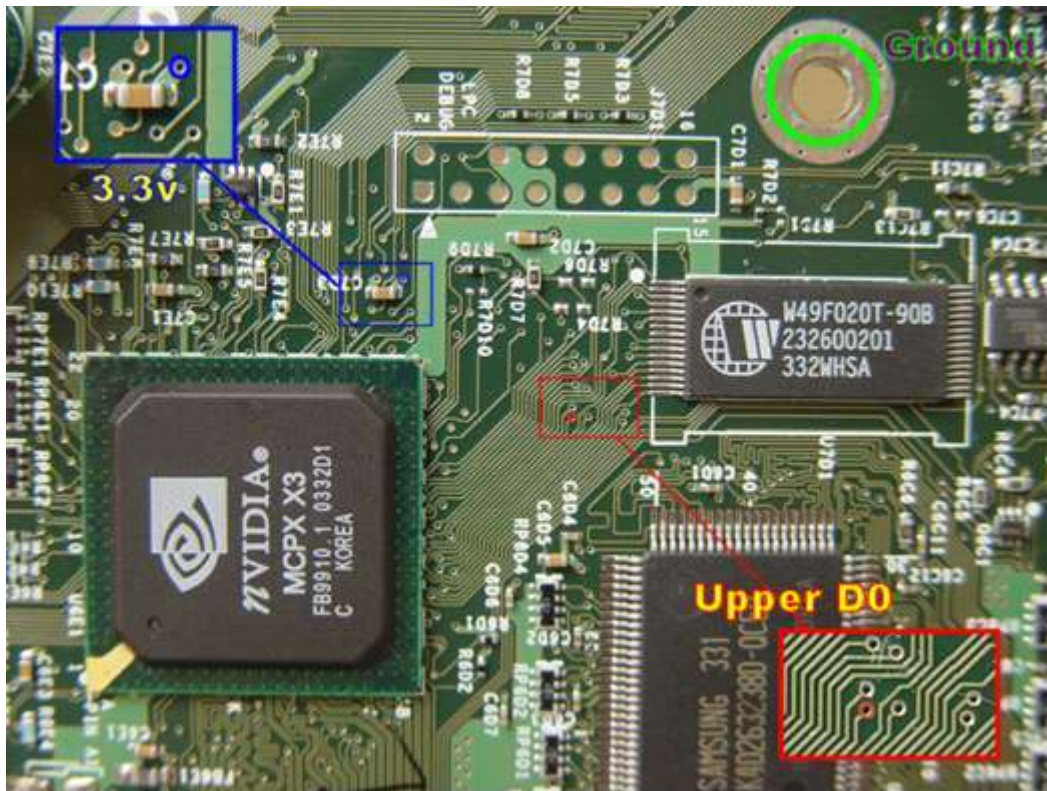
The photo below shows the location of a 3.3v point (marked in blue) and Ground (marked in green).

Solder a piece of wire between the blue point shown in the photo above and the solder pad marked in blue in the photo below. This will provide the Xenium with the 3.3 volts it needs. Also solder a piece of wire between the screw-hole as shown above in green and the pad on the Xenium that is marked in green for the Xenium's Ground connection.
